Transitioning from Prototype to Production: The AC Pipe Scanner

March 5, 2019

Agreement Number: AI 2396A

Principal Investigator: Csaba Ékes, PhD, PGeo, SewerVUE Technology Corp.

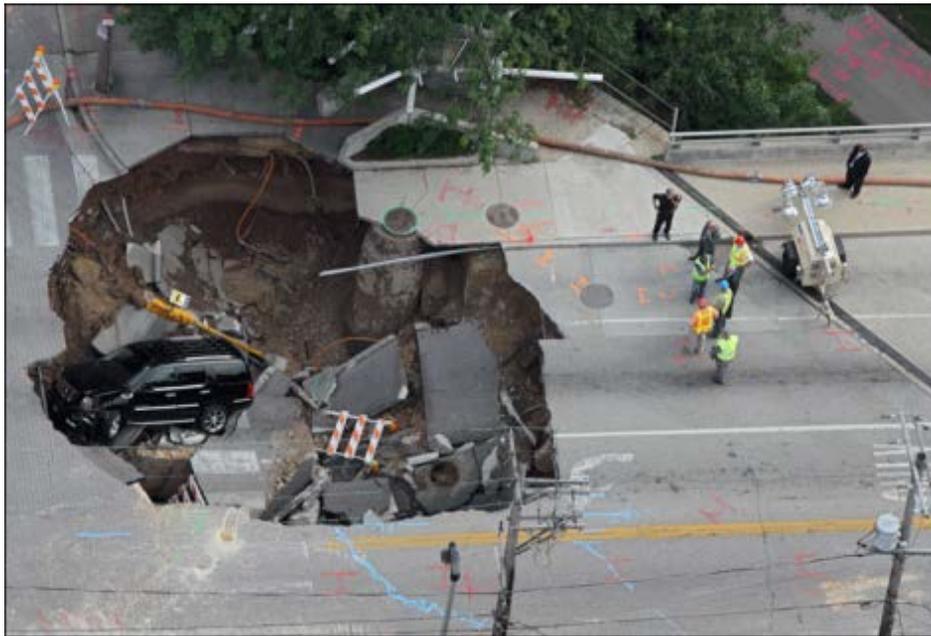
Consequences of catastrophic pipe failure. A common occurrence due to the aging water and sewer infrastructure.

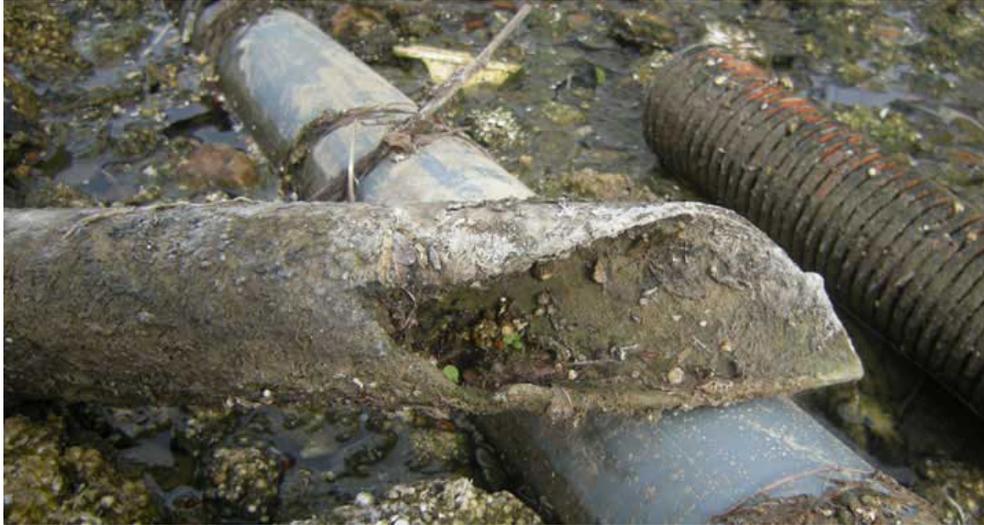
The majority of AC pipes are near the end of their design life.

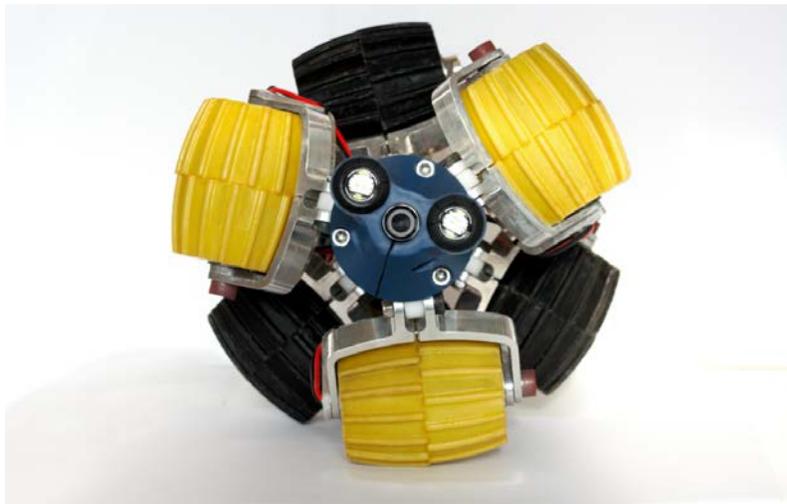
Front view of the ACPS prototype.

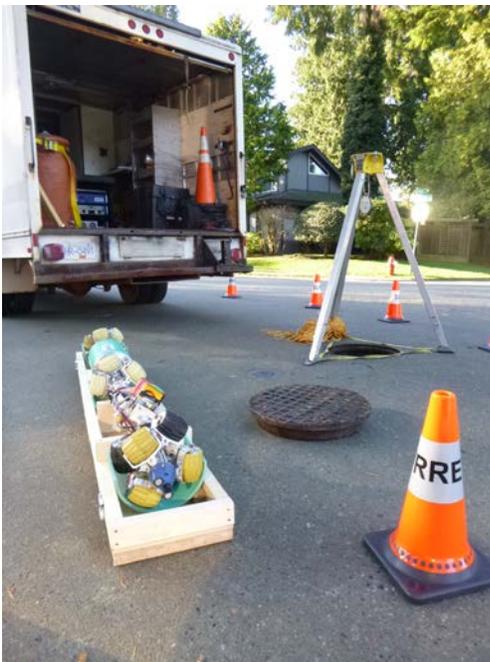
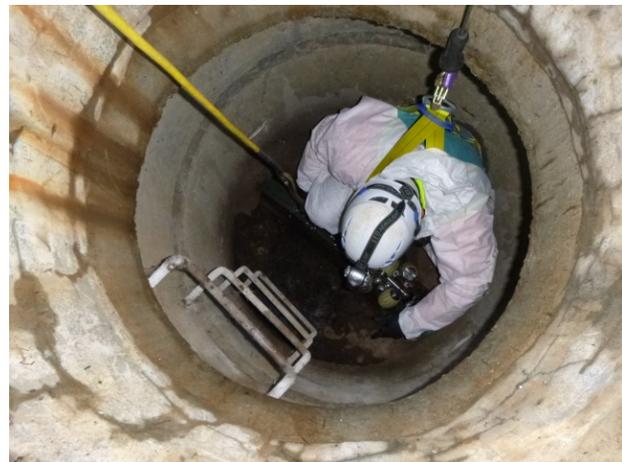
Photos from one of the Surrey, BC in pipe tests showing the inspection truck and robot on site (left) and robot being inserted into the pipe (right).

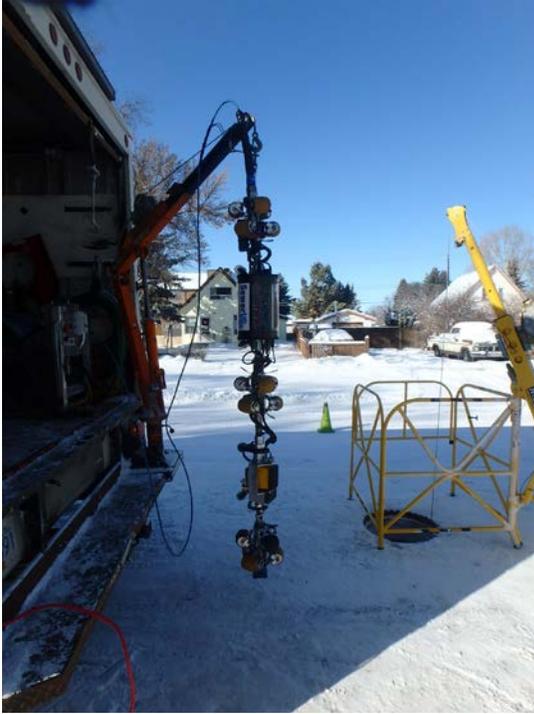
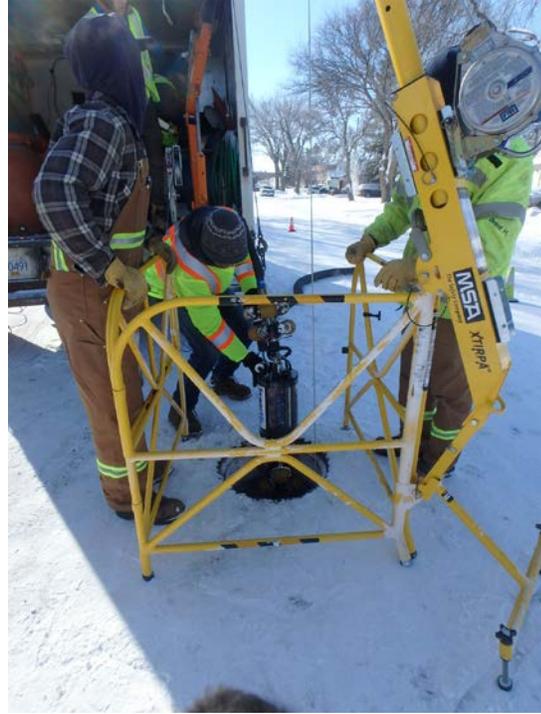
ACPS robot prior deployment (left) and being inserted into manhole (right).

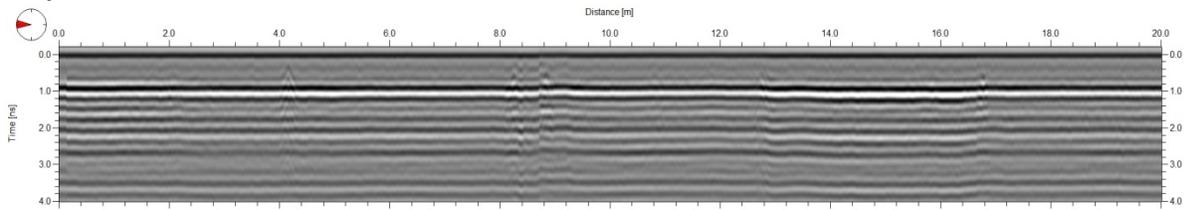
ACPS sample output showing consistent wall thickness (1 ns depth) and pipe joints at every 4.2 metres.

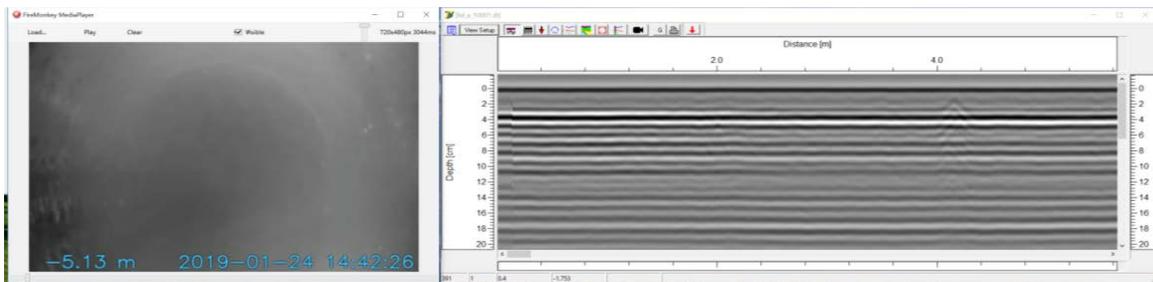
ACPS sample output showing synchronized CCTV (left) and PPR results (right). Anomaly (faint hyperbola) on the PPR profile at 4.15 m is likely a separated joint that is not picked up by CCTV.

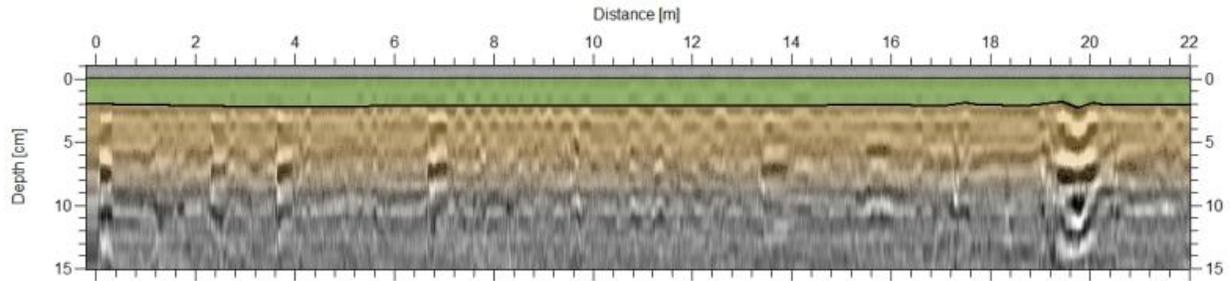
ACPS “classic view” (where interpretation is superimposed on the processed PPR profile) sample output showing 2 cm wall thickness from a 10” AC pipe. Anomalies at 19.8 m show irregularities in pipe bedding.
