CLEAN RESOURCES FINAL REPORT PACKAGE

Project Title:	Alternative Road Construction to Reduce Peatland Water Flow Obstruction: CNRL Pad TT Road
Alberta Innovates Project Number:	G2019000341
Submission Date:	22 December 2022
Total Project Cost:	\$193,073.00
Alberta Innovates Funding:	\$50,000.00
AI Project Advisor:	Dallas Johnson

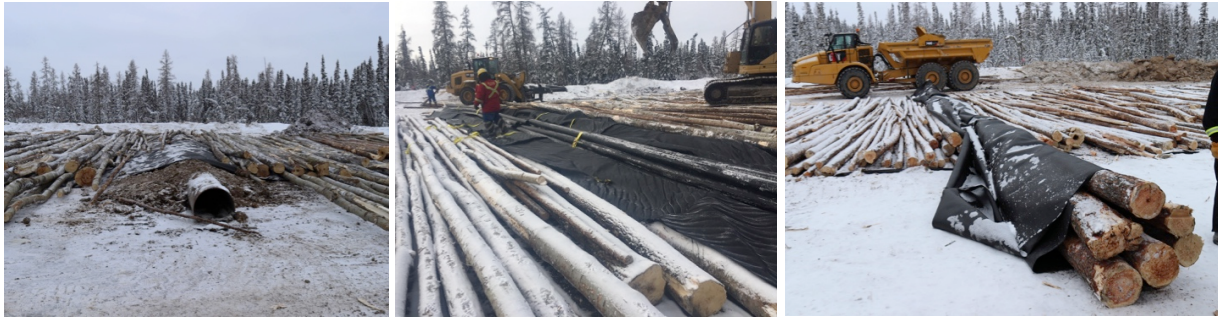
Figure 4. Left: Pre-embedded solid steel culvert covered with mineral fill and abutted with logs. Centre: HDPE pipe bundle being installed among corduroy logs. Right: Log bundle wrapped in a geotextile placed among corduroy logs.

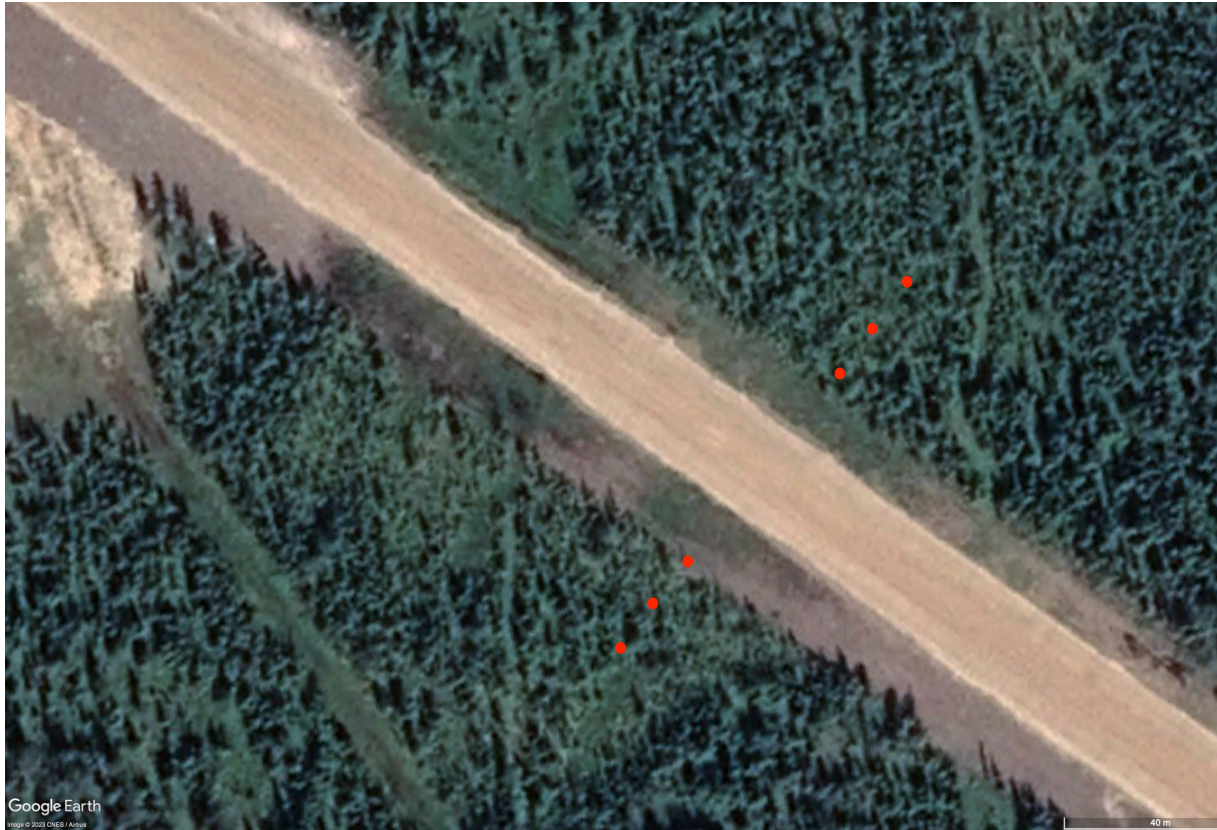
Figure 6. Example of water well placement in original transects established in 2018. Wells were placed 15, 30, and 45 m from each edge of the road. Water flow is from southwest to northeast. Image is of Transect 3 area shown in Figure 5 above.

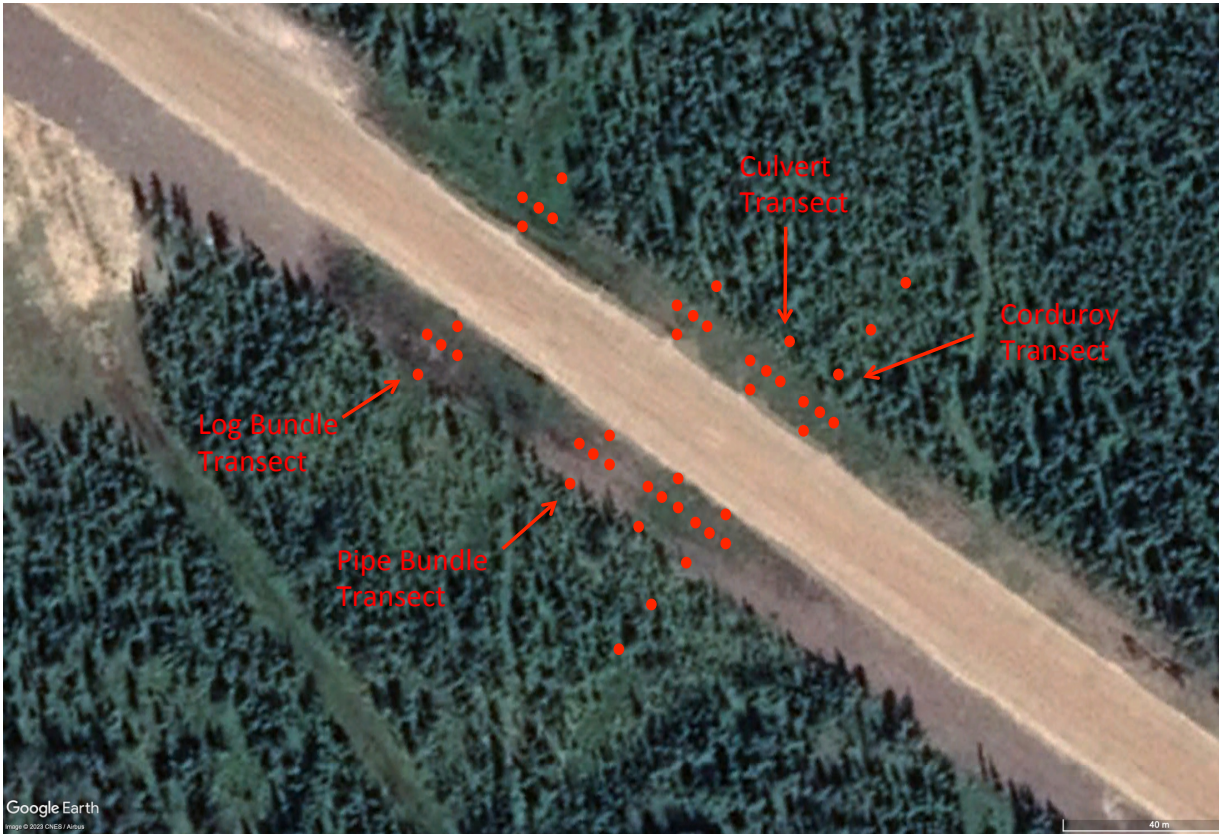
Figure 7. Layout of well and piezometer transects for conduit performance assessment. Wells were placed at 1, 5, and 15 m from each edge of the road immediately in front of a culvert, log bundle, and pipe bundle. Piezometers were installed approximately 1 m on either side of the well at 5 m from road edge. The southeast-most transect incorporated the original well transect established in 2018 and was situated between a pipe bundle and culvert.

Two piezometers were also installed at the 5 m from road edge distance for each of the newly established transects, approximately 1 m on either side of the at that location (Figure 7). Slotting depths were selected to target the middle and near bottom of the peat profile. Since peat depth was generally 1.8 to 2 m, slotting depths were 85 cm for the middle and 155 cm for the bottom piezometer at each

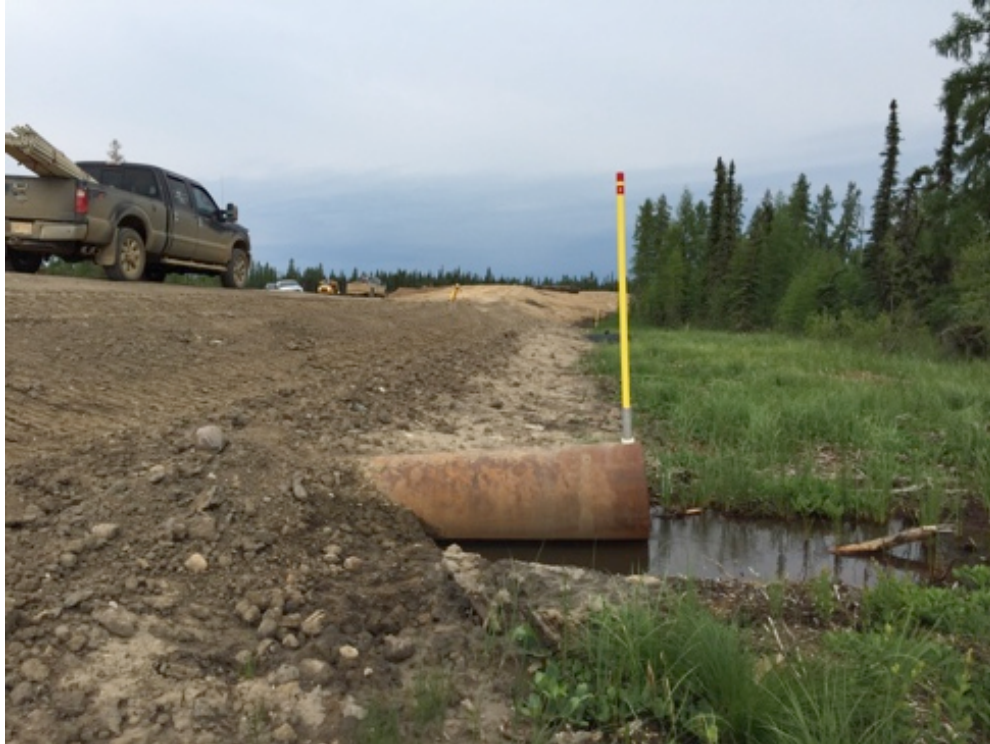
Figure 8. Example of culvert distortion, causing upward deflection of the outlet. Such distortion is common with peatland roads. Corrugated steel culverts are more prone to distortion than steel pipe, like the one pictured.

Road and conduit elevation surveys were successfully completed and compared to initial surveys completed during the late summer after initial construction. Most road settling had occurred during the first year, with little additional settling observed during the subsequent survey, indicating that settlement may be approaching equilibrium. However, there was additional movement of some culverts between the initial and subsequent surveys. While distortion of a number of culverts occurred due to road settling (Figure 8), as is common on roads constructed in peatland, they continued to move water from the upstream to downstream sides of the road.

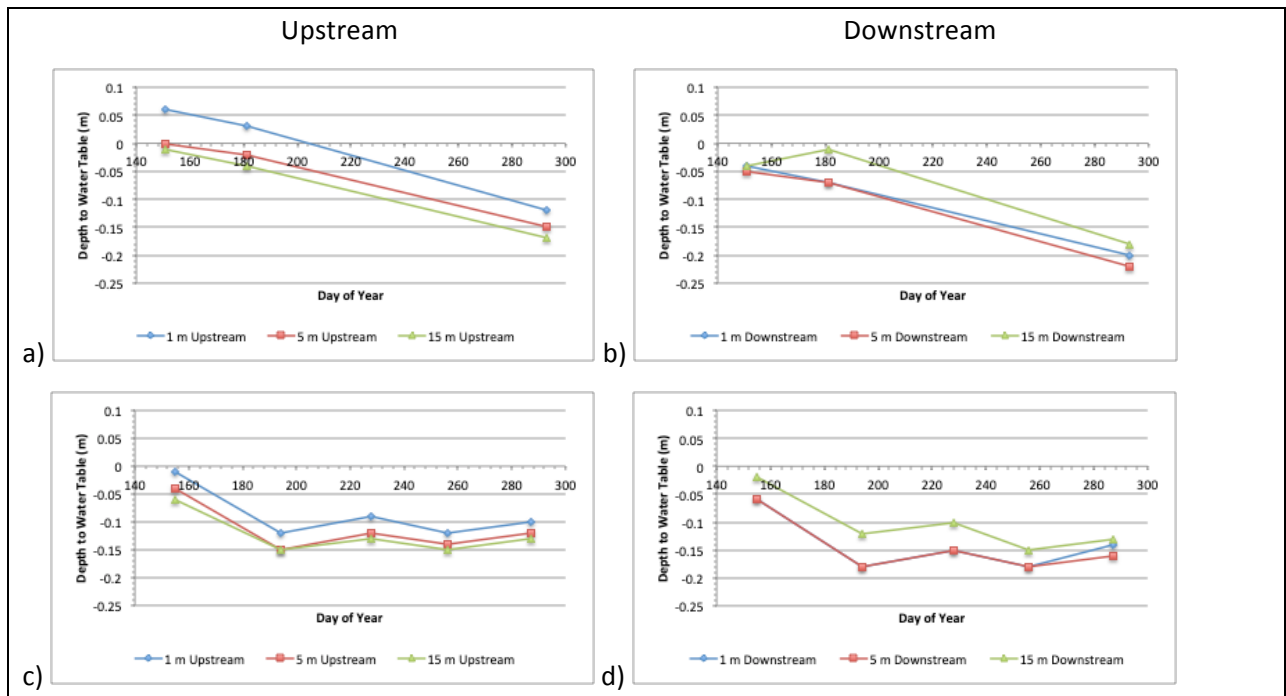
Figure 10. Corduroy transect depth to water table recorded manually at wells 1 m, 5 m, and 15 m from road edge in 2022 ('a' and 'b') and 2021 ('c' and 'd').

DTW was almost always greater on the downstream side of the road than the upstream side for all conduit, corduroy, and control transects (Figures 9 to 13). The across road difference was always greatest at the control transect. The water table was above the ground surface on the upstream side of the control transect during the highest site average water table events from early to late June (Figure 9). DTW ranged from 18 to 20 cm deeper on the downstream side than upstream side at the control transect in 2021 and was generally 10 cm deeper in 2022. On the other hand, DTW was 1 to 4 cm deeper on the downstream side than upstream for corduroy, culvert, and pipe bundle transects in 2021 and 7 to 8 cm deeper in 2022 (Figures 10 to 12). DTW was 3-8 cm deeper on the downstream side than upstream for the log bundle transect in 2021 and 9 cm deeper in 2022 (Figure 13).

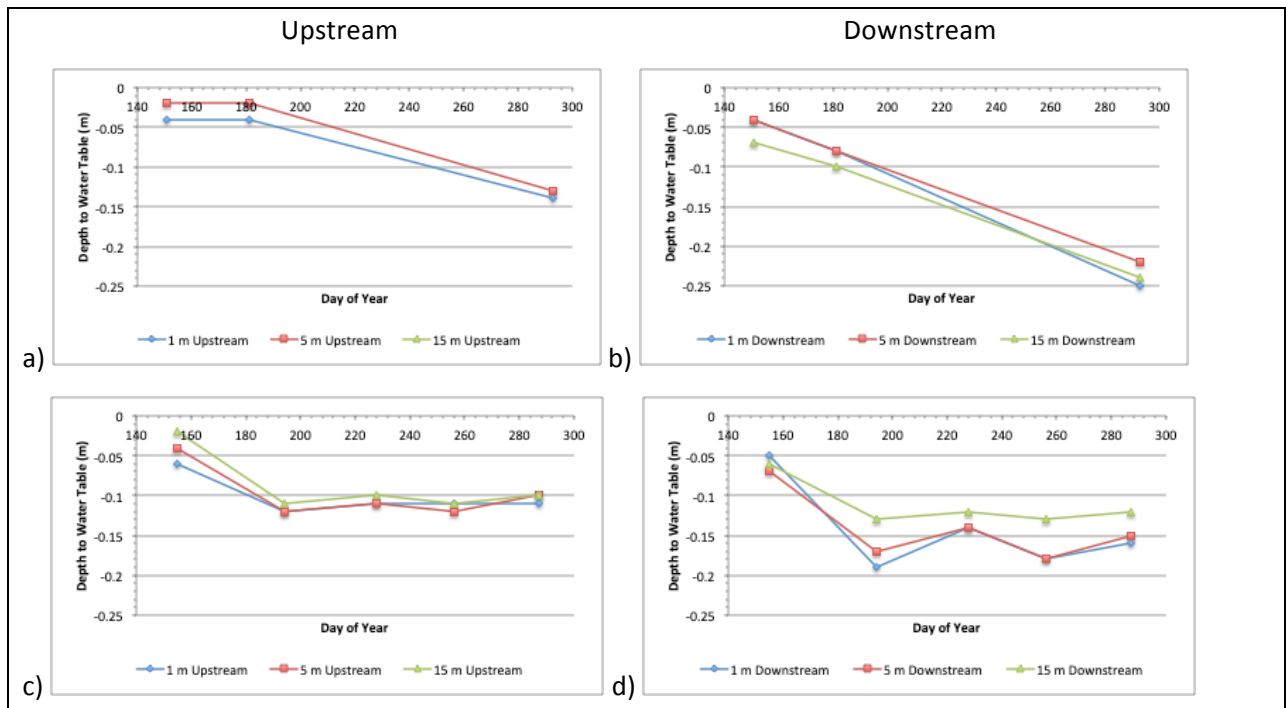
Figure 12. HDPE Pipe Bundle transect depth to water table recorded manually at wells 1 m, 5 m, and 15 m from road edge in 2022 ('a' and 'b') and 2021 ('c' and 'd').

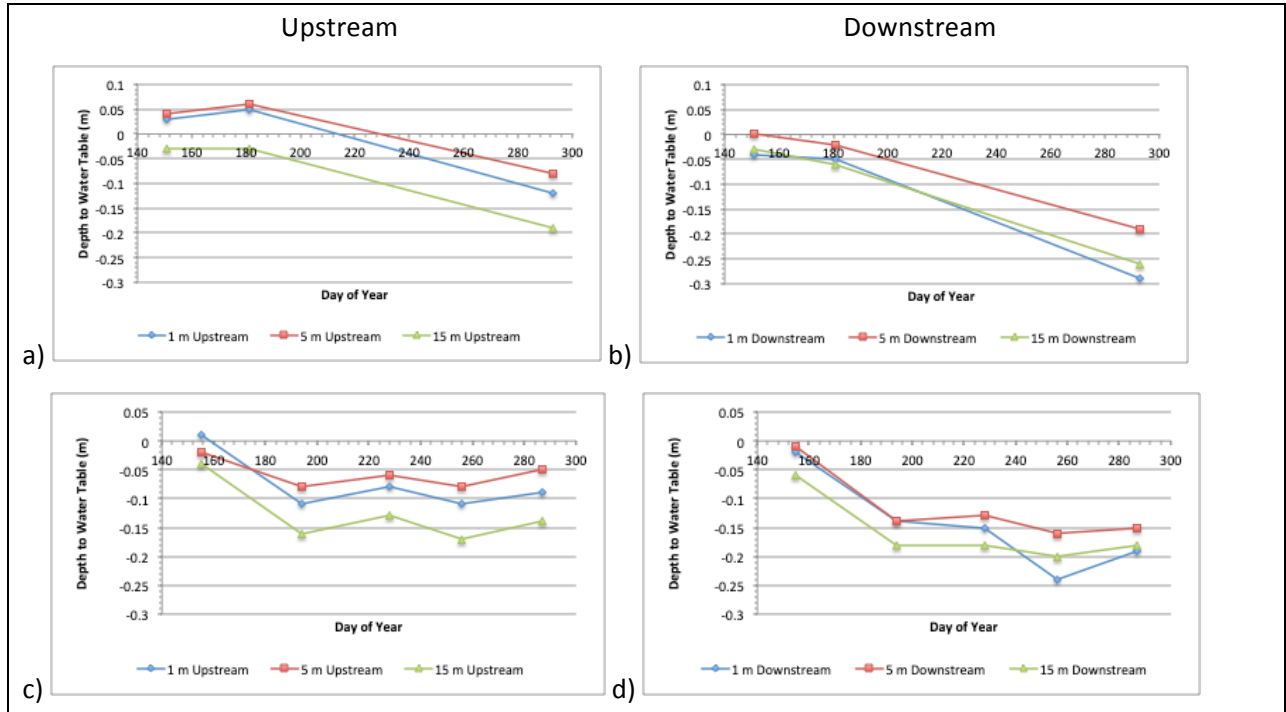
Figure 13. Log Pipe Bundle transect depth to water table recorded manually at wells 1 m, 5 m, and 15 m from road edge in 2022 ('a' and 'b') and 2021 ('c' and 'd').

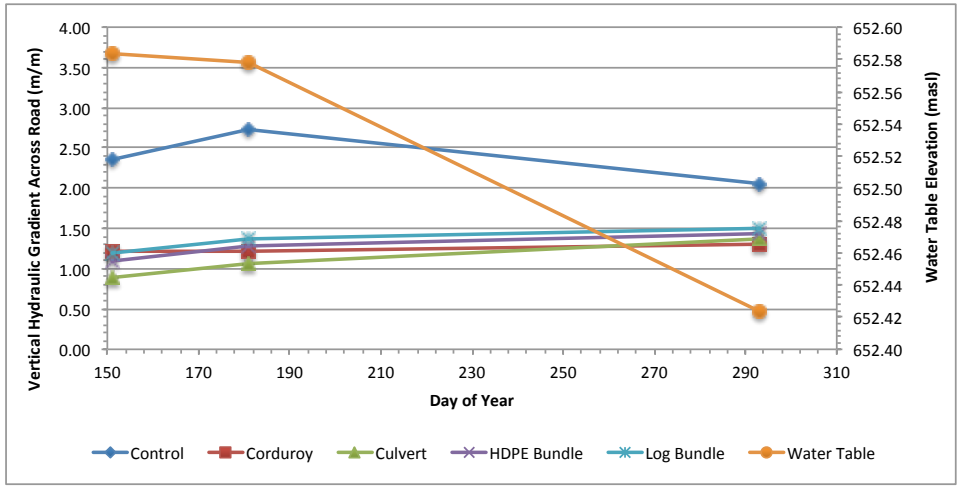
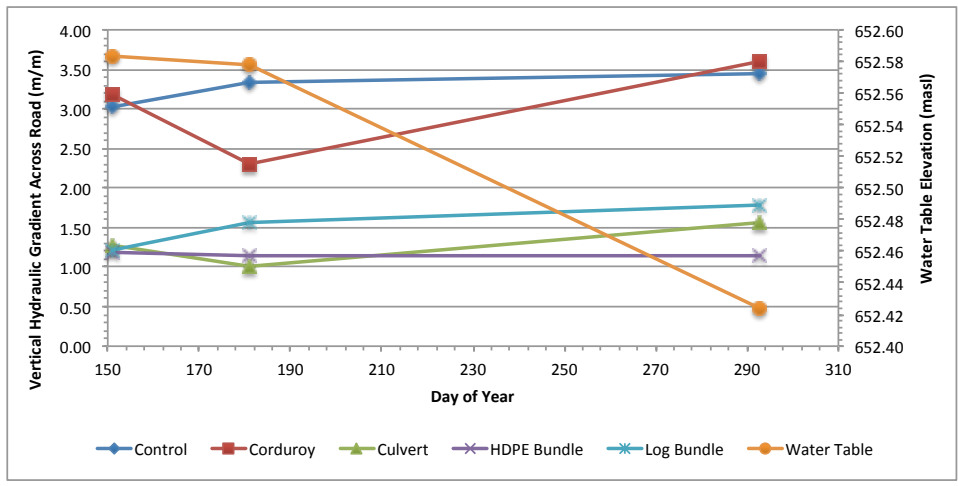
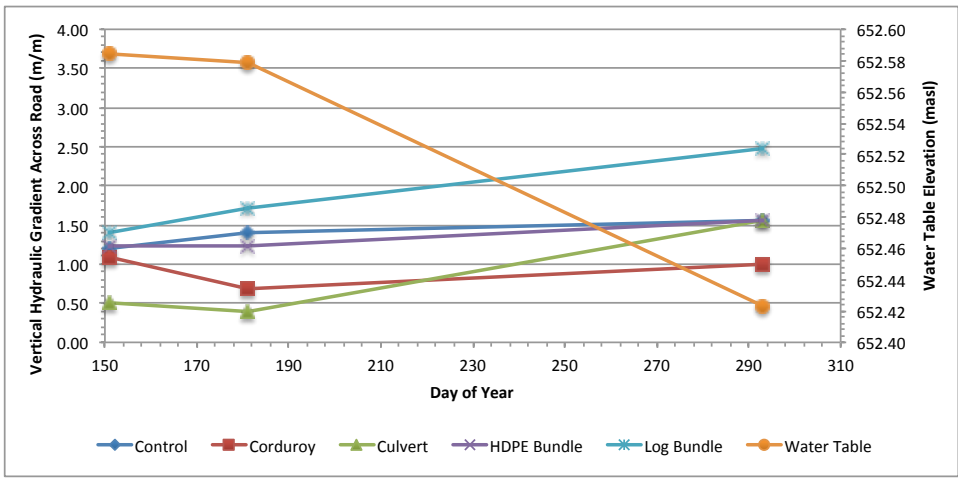
Figure 15. Hydraulic gradients between upstream and downstream sides of road at wells (a), 85 cm slotted piezometers (b), and 155 cm slotted piezometers (c) in 2022. Gradients greater than 1 are steeper than the topographic gradient between the upstream and downstream sides of the road.

There was a topographical gradient sloping from the upstream to downstream side of the road. Therefore, if the water table was parallel with the ground surface, a hydraulic gradient would also be observed, which would normally be expected in absence of the road. However, since DTW was generally deeper on the downstream side than the upstream side, the inference is that the hydraulic gradient was steeper than the topographic gradient and the road has impeded flow. The steepness of hydraulic gradients varied among conduits, corduroy, and control, as well as with peat depth (Figures 15 and 16). Hydraulic gradients measured between wells at 5 m from the road edge on either side of the road represent water intake from the top 1.15 m of the peat surface, whereas, gradients measured between piezometers on either side of the road represented conditions at specific depths within the peat profile. The hydraulic gradient between upstream and downstream sides of the road at the control transect was on average 173% steeper than the topographic gradient for wells, whereas the gradients were closer to parallel with the topographic gradient, though still steeper for the corduroy and conduit transects. The average hydraulic gradients for all measurement dates were 18%, 6%, 23%, and 31% steeper than the topographic gradient for corduroy, culvert, pipe bundle, and log bundle transects, respectively. The average hydraulic gradient between 85 cm piezometers on either side of the road were 218%, 174%, 23%, 4%, and 40% steeper than the topographic gradient for control, corduroy, culvert, pipe bundle, and log bundle transects, respectively. The hydraulic gradient between road sides at 155 cm piezometer depth was 68% steeper than the topographic gradient at the control transect, 13% less steep at the corduroy and culvert transects, and 38% and 63% steeper at the pipe and log bundle transects.

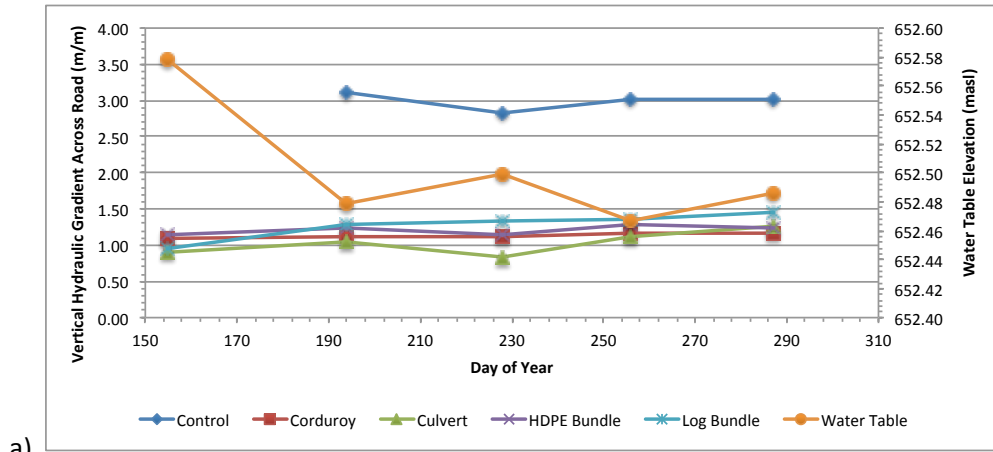
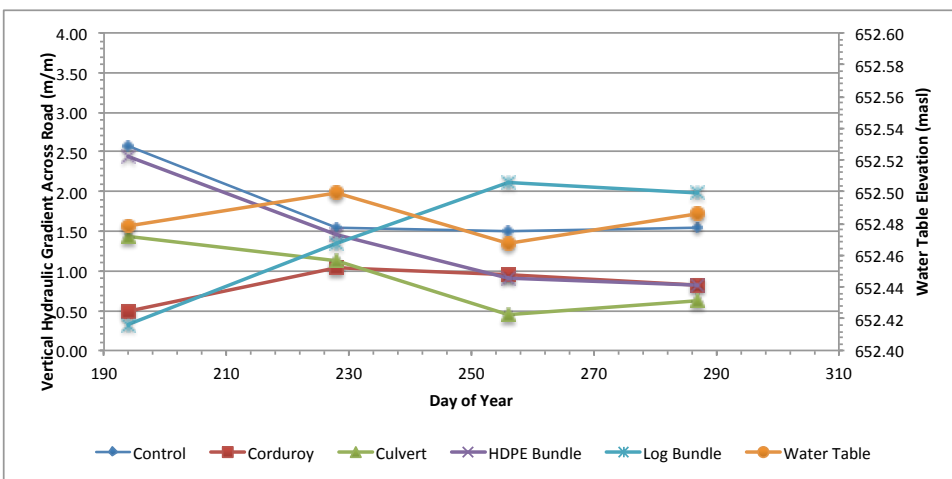
Figure 16. Hydraulic gradients between upstream and downstream sides of road at wells (a), 85 cm slotted piezometers (b), and 155 cm slotted piezometers (c) in 2021. Gradients greater than 1 are steeper than the topographic gradient between the upstream and downstream sides of the road.

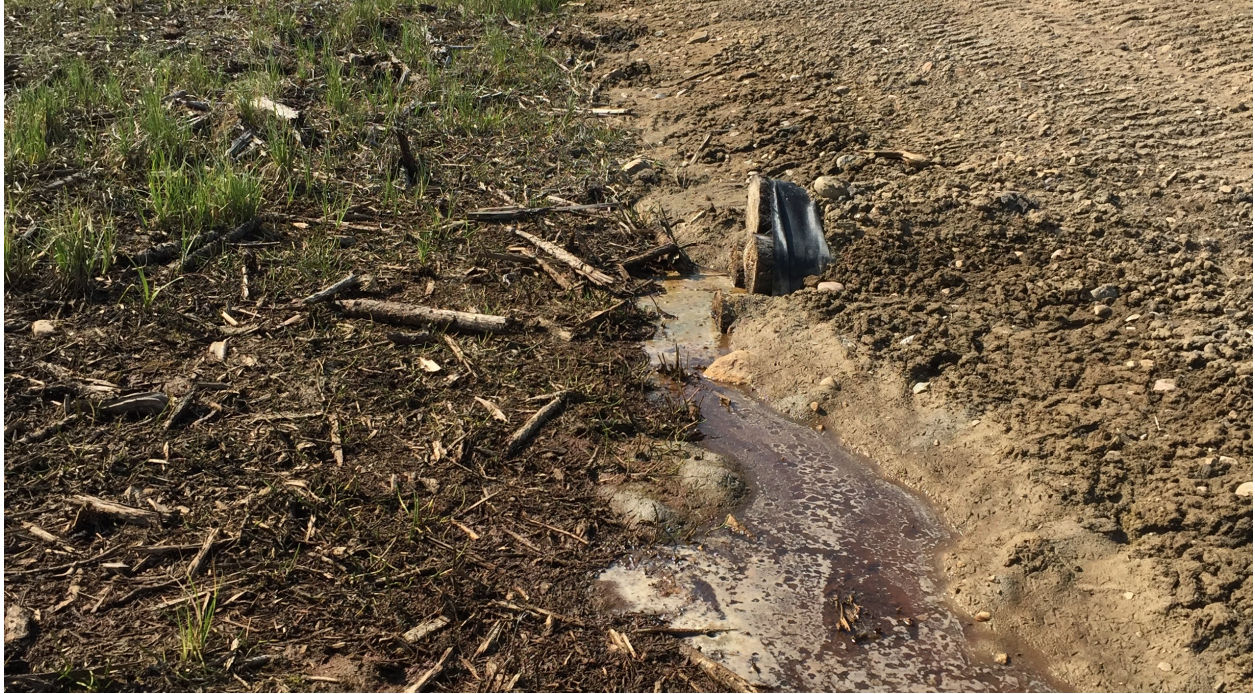
Figure 17. Water along road edge draining into a log bundle during second season post road construction.

Properly installed, culverts are the most free-flowing conduits, however, both pipe and log bundles also move water fairly well (Figures 17 and 18). Therefore, all of the conduits examined are useful in promoting road permeability, but choice of conduit type and placement should be made based on enhanced assessment of peatland hydrologic conditions prior to road construction. Since most road drainage designs rely primarily on models of surface flow, assessment of subsurface flows should be integrated into drainage designs. Conduit type, size, depth, and spacing could then be selected based on a better estimate of water volumes required to be moved in conjunction with cost and availability of conduit materials. All of the conduits used here are relatively low cost as they were salvage materials from other operations. Salvage steel pipe of various diameters is often available in association with in situ oil sands developments. The HDPE pipe for the pipe bundles were surplus pipe liners, and the logs for corduroy and bundles were salvaged material from clearing for local development. Continuous steel pipe performs better than corrugated steel culverts and is much more economical if it is acquired as salvage from associated in situ operations. The HDPE pipe liners may not always be available but are a good option when they are. Similarly, the only cost associated with salvage logs is transportation to site, but this can be minimal if the salvage coincides with the development that a road is supporting. Conduit type, size, depth, and spacing should be optimized by the relative availability of each, as well as alternatives, and the drainage requirements of the specific peatland in which the road is built.

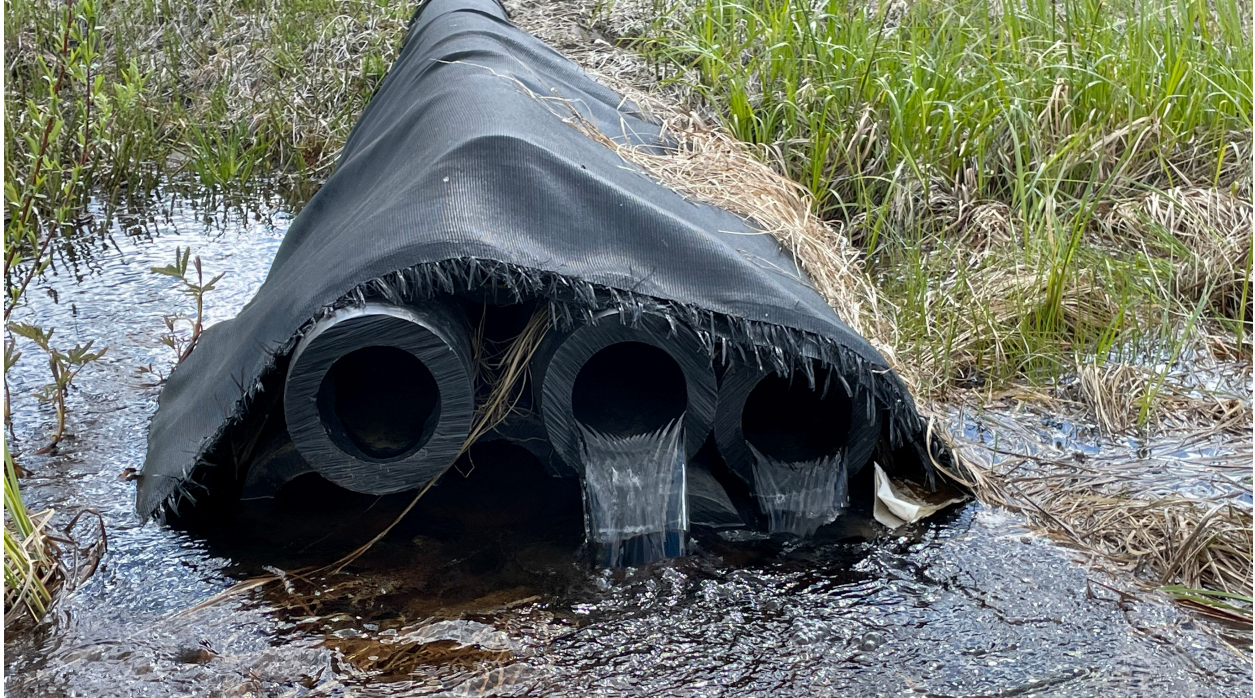
Figure 18. Water flowing out of pipe bundle outlet in late May 2022.

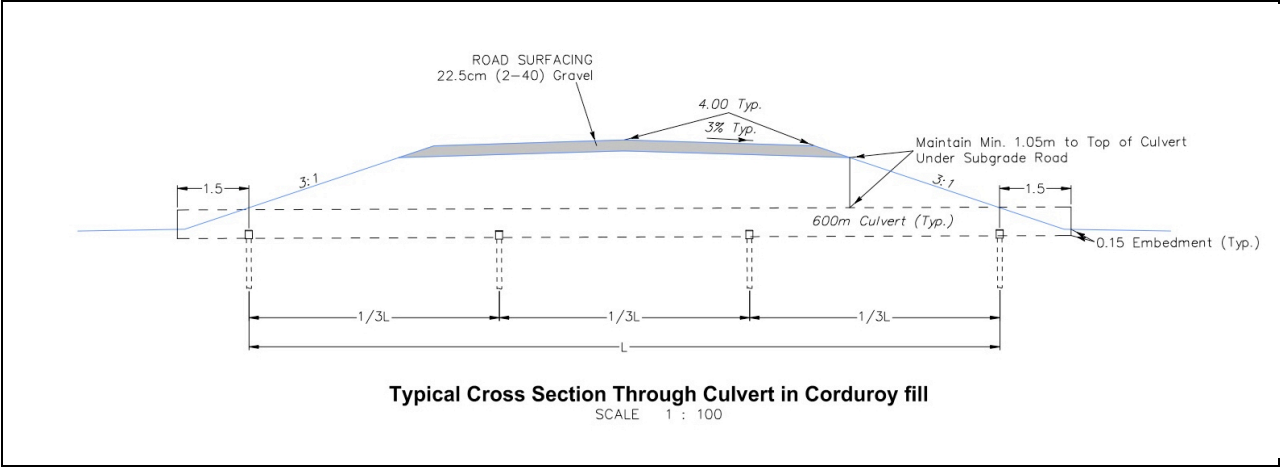
Figure 19. Design drawing of pile placement under culverts. Eliminating the two outside piles may allow culverts to settle more evenly and reduce bowing (Drawing produced by All-Can Engineering & Surveys (1976) Ltd.).

While it is common for culverts to bow as peatland roads settle, culverts used in this road were placed on four piles to prevent settling (Figure 19.). However, depth of fill in the middle of the road would have exerted more pressure on the under-road piles than shoulder piles. Redistribution of piles under the road focusing on the deepest fill and minimizing support under road shoulders may have reduced bowing of culverts observed in this study.
